THE UNITED STATES
STRATEGIC BOMBING SURVEY

THE EFFECTS
OF
THE ATOMIC BOMB
ON
HIROSHIMA, JAPAN

Volume III

Physical Damage Division

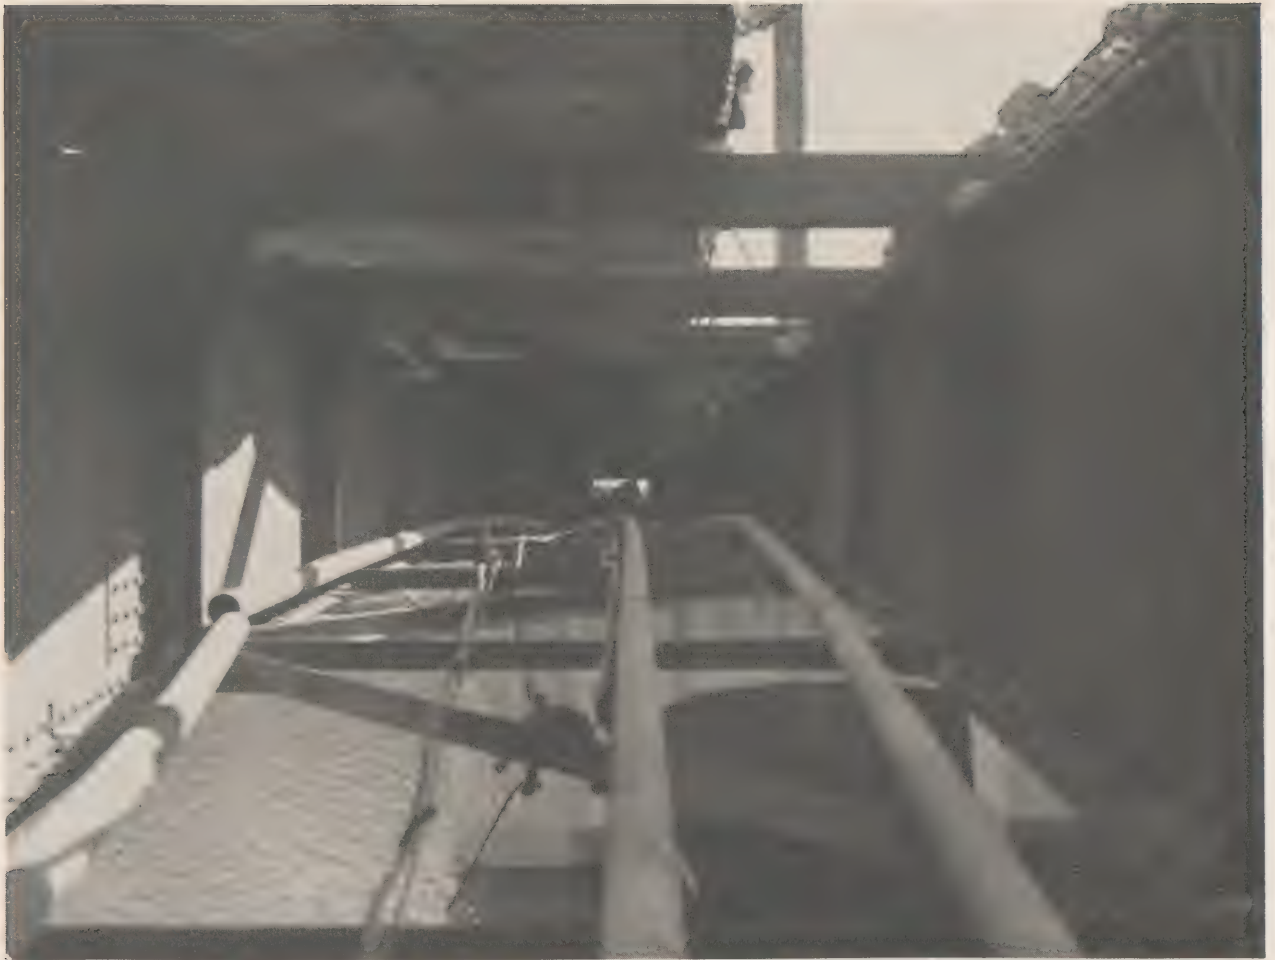
PHOTO 67-XII. Bridge 24. Inside faces of plate girders, fifth span from east abutment under north walk. Deflected slightly by blast (1,000 feet to GZ, 2,230 feet to AZ).

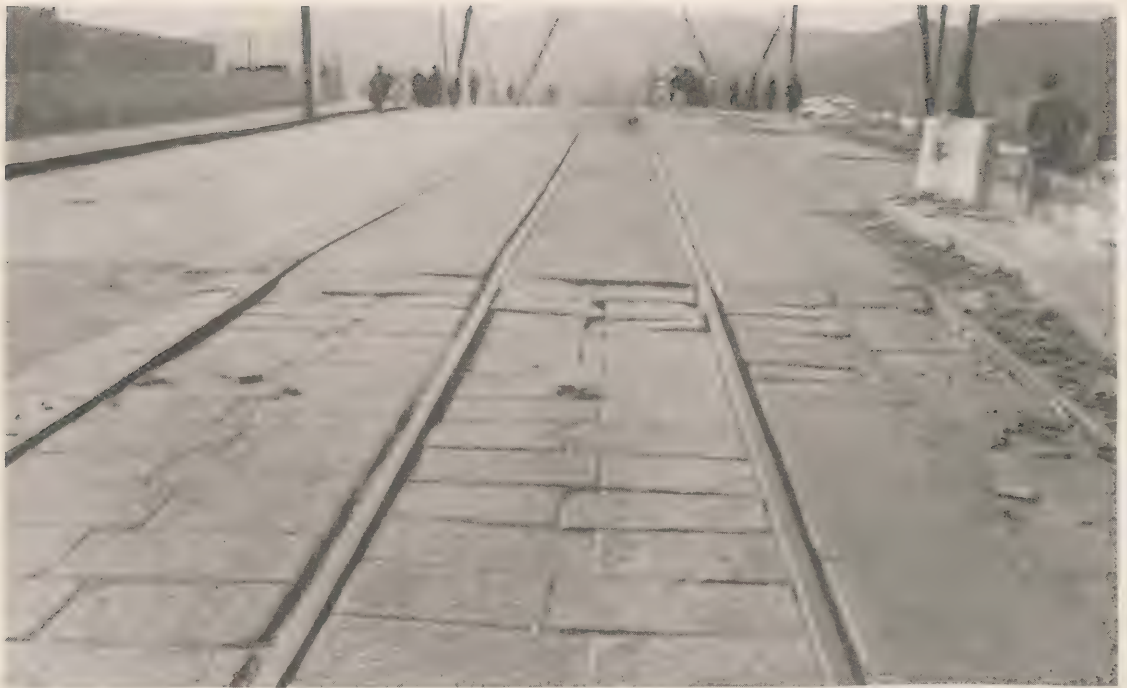
PHOTO 68-XII. Bridge 24. East end of bridge. Slight deflection in trolley rails due to shifting of bridge deck by blast.

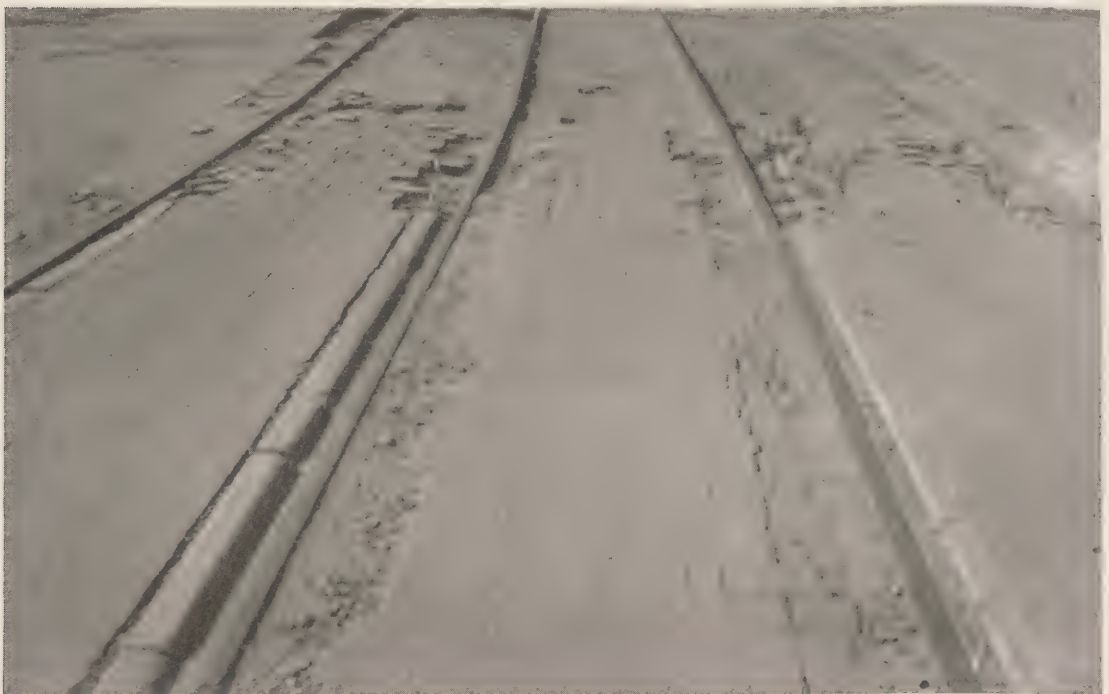
PHOTO 69-XII. Bridge 24. West end of bridge. Streetcar rails moved laterally 15 inches to the north when blast effects shifted bridge deck (1,000 feet to GZ, 2,230 feet to AZ).

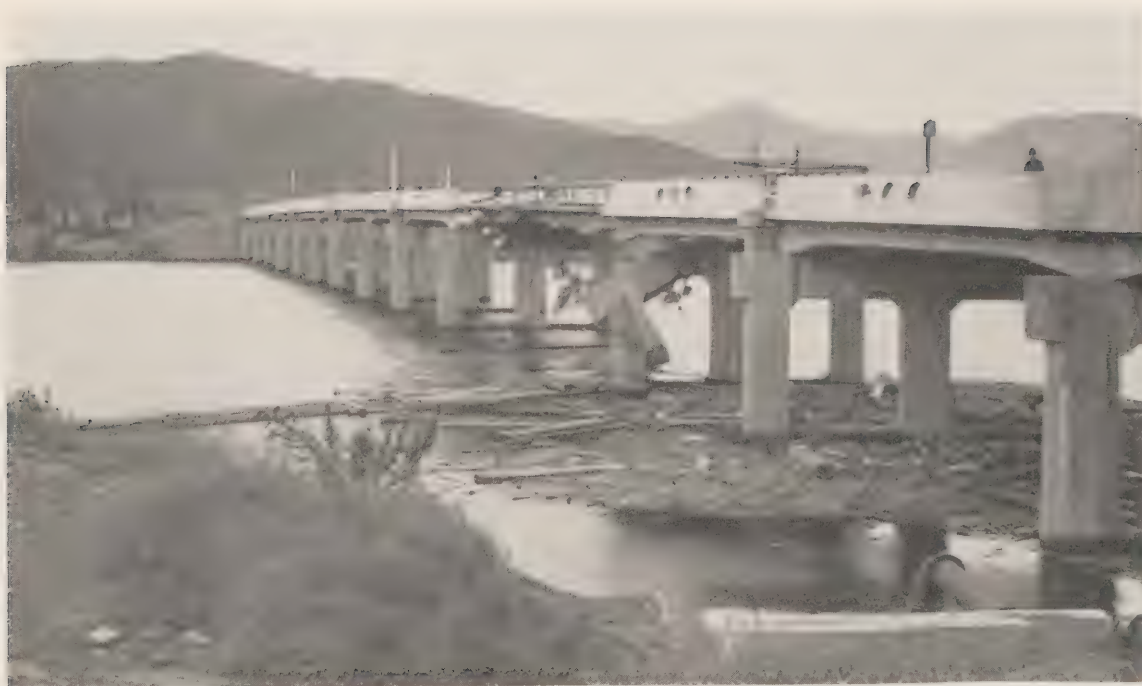
(9) *Bridge 25* (5,200 feet from GZ and 5,570 feet from AZ). The fourth bent from the south abutment was completely washed out by flood, but the bridge continued to carry unrestricted traffic. It also received superficial damage when blast blew off the concrete coping along both sides and slightly damaged the railing balusters directly over each pier (Photo 71 and Fig. 13).

PHOTO 71-XII. Bridge 25. West elevation of bridge over Ota-Gawa. Flood damage and superficial damage to concrete coping by blast (5,200 feet to GZ, 5,570 feet to AZ).

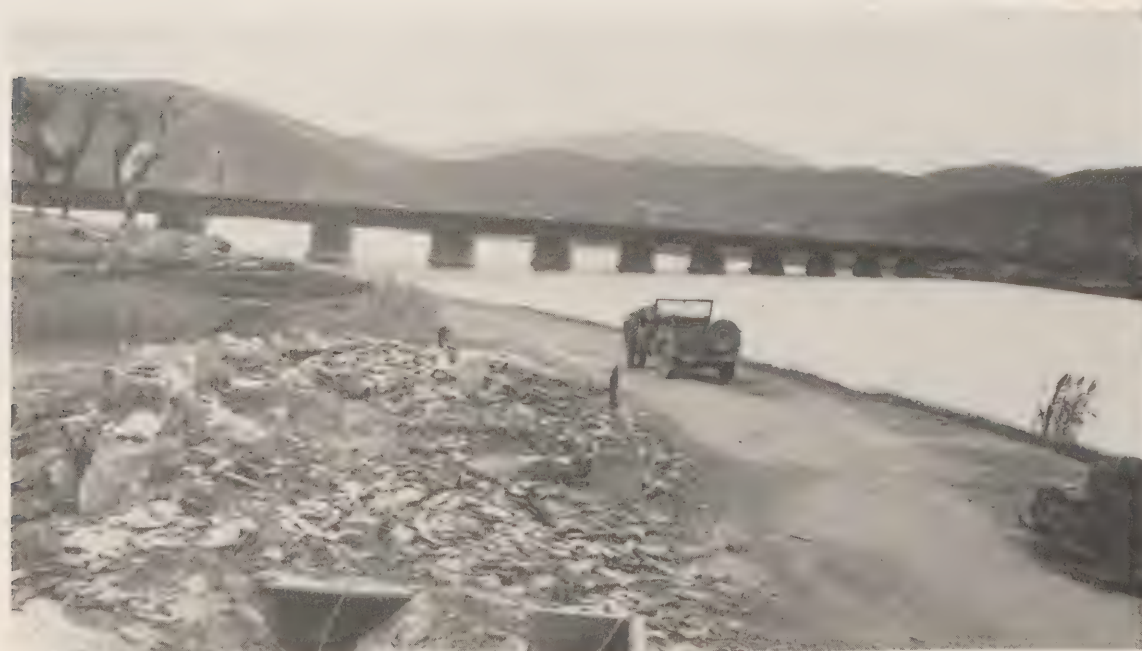
(13) *Bridge 26* (5,750 feet from GZ and 6,100 feet from AZ) suffered no structural damage. The bomb effects, however, discolored the old paint on the steel members along the south side facing the direction of flash. The north side was unaffected (Photos 72, 73, 74).

PHOTO 72-XII. Bridge 26. South elevation of undamaged, double-track railroad bridge over Ota-Gawa (5,750 feet to GZ, 6,100 feet to AZ).

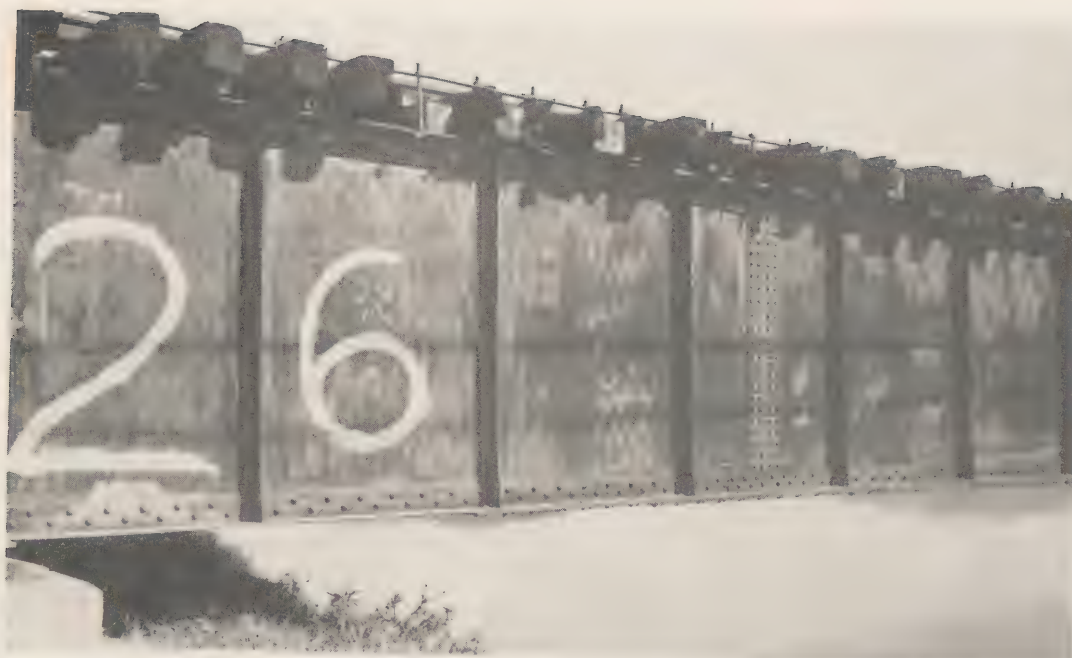
PHOTO 73-XII. Bridge 26. Paint on the south elevation of girders discolored by exposure to bomb effects.

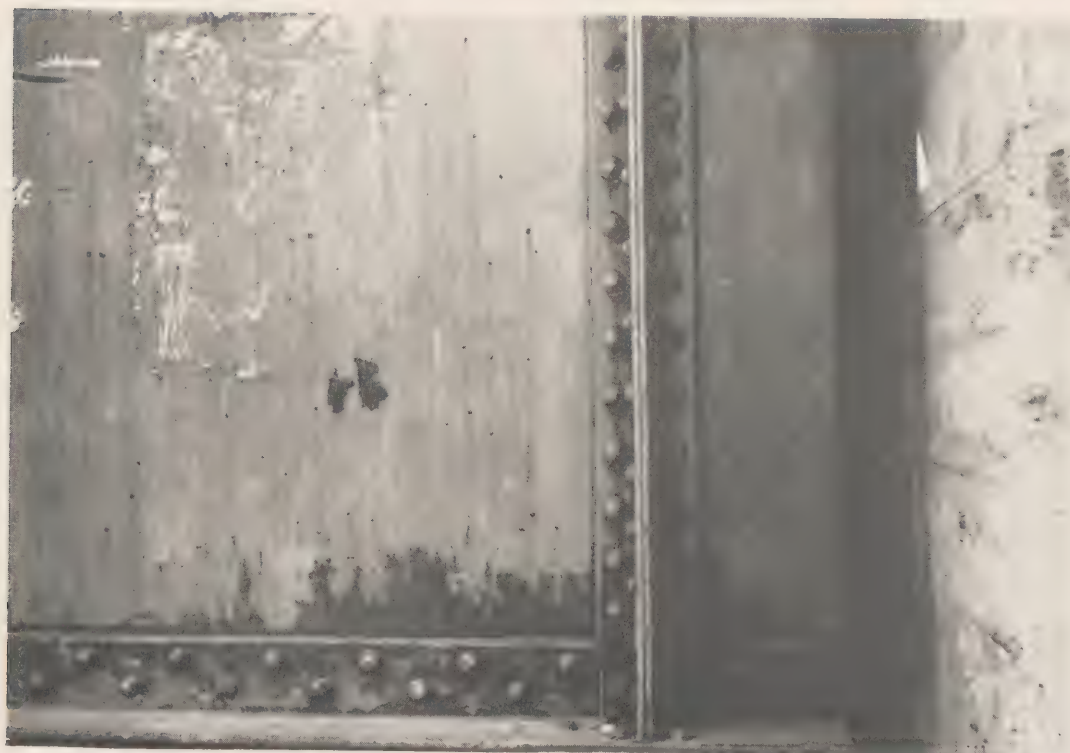
PHOTO 74-XII. Bridge 26. Paint on the north elevation of girders unaffected by bomb effects (5,750 feet to GZ, 6,100 feet to AZ).

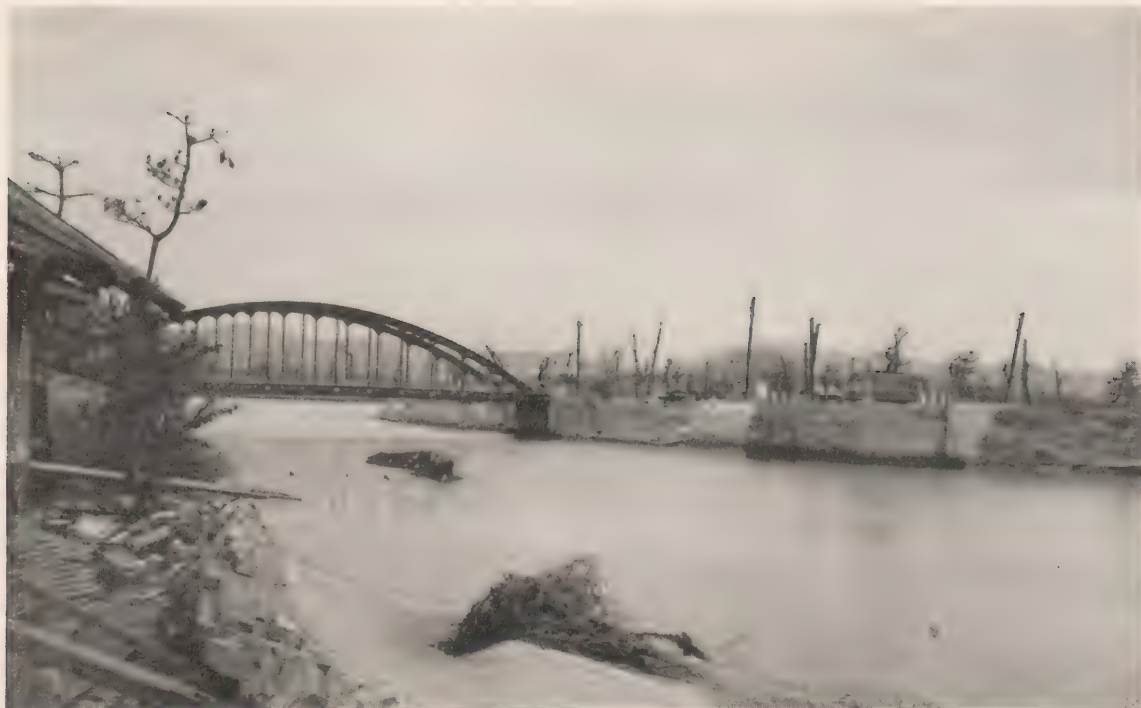
along the west side were less affected (Photo 75). The bridge was of tied-arch single-span construction.

PHOTO 75-XII. Bridge 27. West elevation of undamaged bridge over the Temma-Gawa. Paint on the members of the east elevation were discolored by exposure to bomb effects. Steel members of west elevation were only slightly discolored (4,360 feet to GZ, 4,790 feet to AZ).

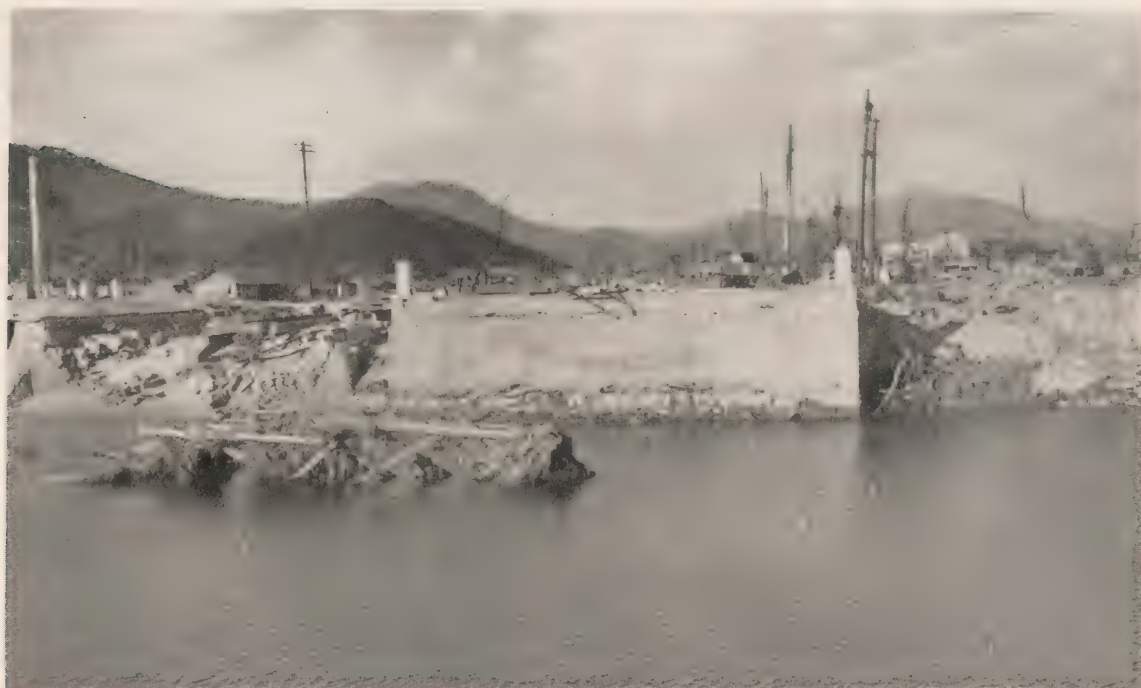
(9) *Bridge 28* (4,430 feet from GZ and 4,840 feet from AZ) was totally damaged by flood (Fig. 19, and Photo 76).

PHOTO 76-XII. Bridge 28. Remains at north abutment of bridge over the Temma-Gawa. Totally damaged by flood (4,430 feet to GZ, 4,840 feet to AZ).

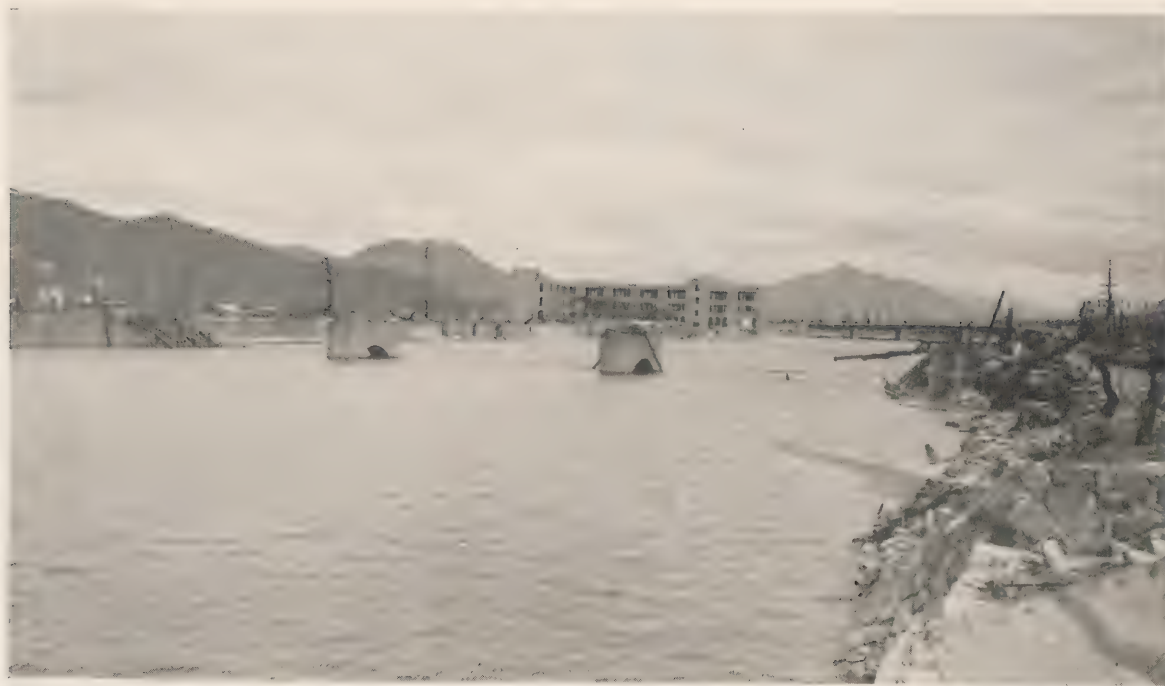
PHOTO 77-XII. Bridge 29. Looking north at remains of bridge over the Ota-Gawa. Totally damaged by blast.

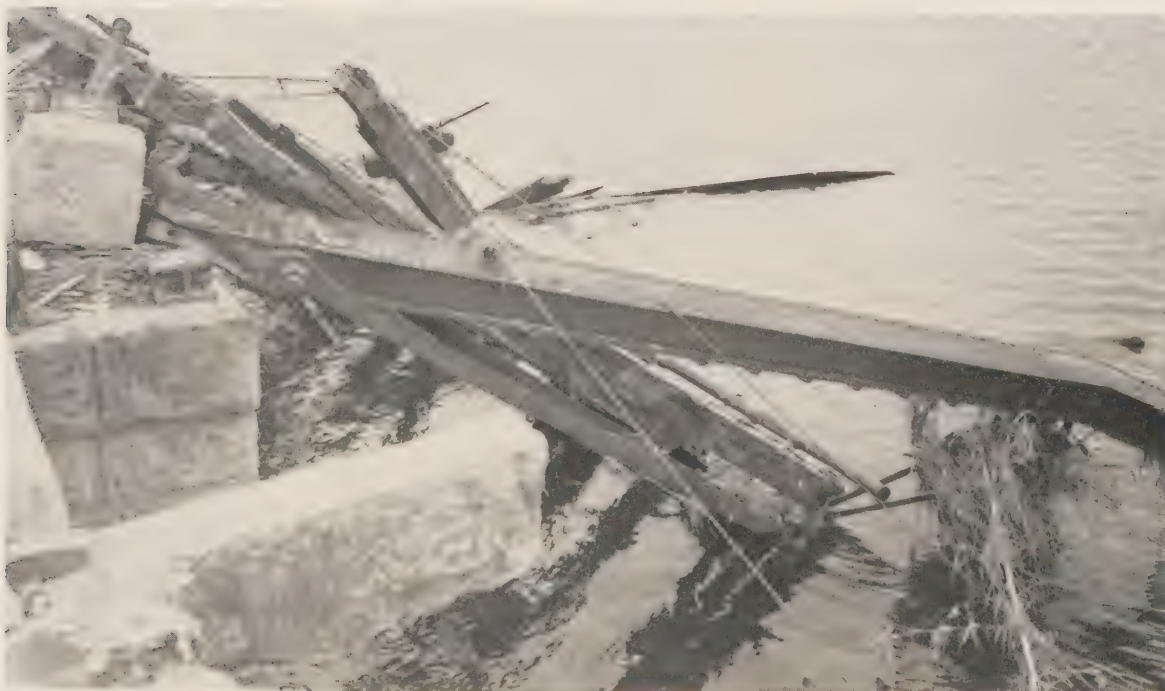
PHOTO 78-XII. Bridge 29. Southwest corner. Totally damaged by blast (1,190 feet to GZ, 2,310 feet to AZ).

NE, SE, and SW ornamental cast iron light posts entirely dislodged.
Upper portion of NW corner light post sheared off as shown and blown 50' SW from original position.
Photo 78.

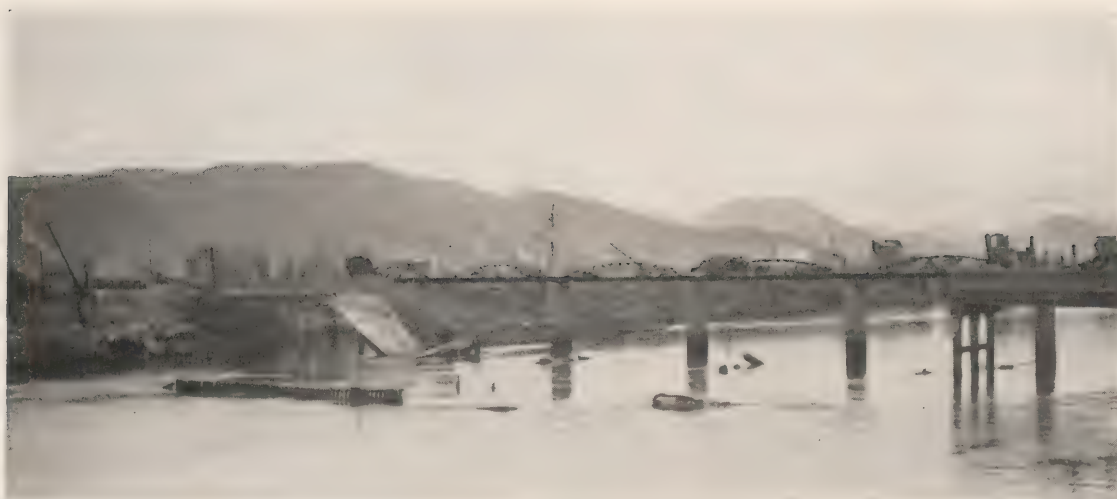
(10) *Bridge 30* (1,930 feet from GZ and 2,800 feet from AZ), the nearest concrete bridge to GZ, was severely damaged by flood only (Photos 81–84 and Fig. 16).

PHOTO 81-XII. Bridge 30. Looking north at flood damage to highway bridge over the Ota-Gawa.
(Note Bridge 30-A, aqueduct.)

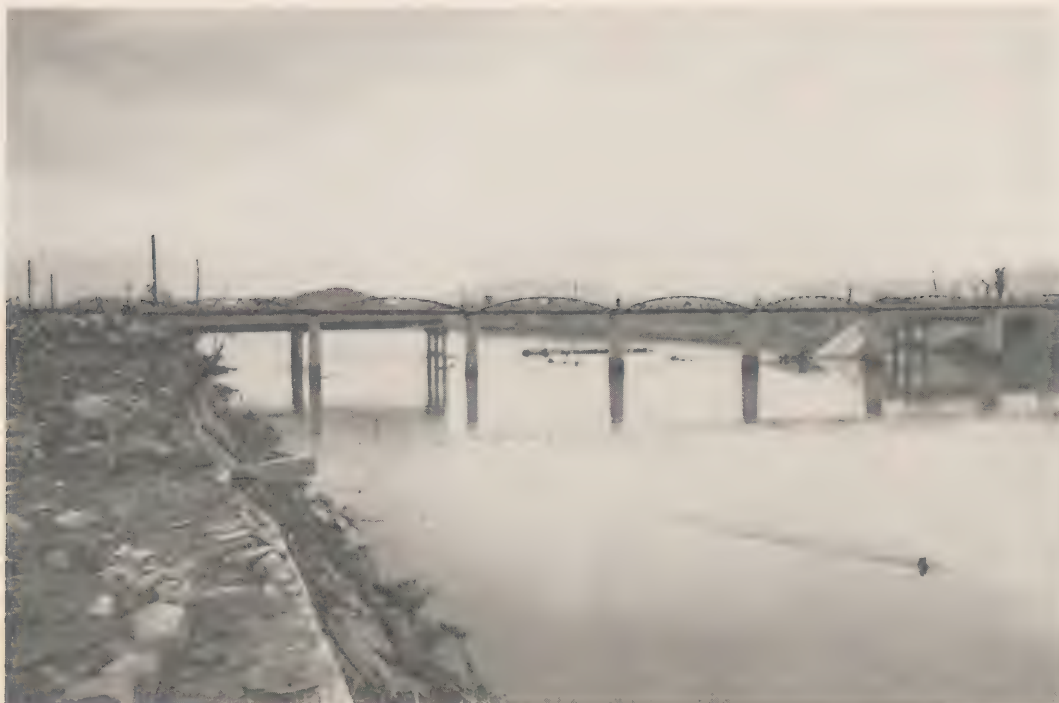
(16) *Bridge 30A* (1,880 feet from GZ and 2,750 feet from AZ) suffered slight damage by blast. This bridge, known as the Shinobashi Aqueduct, carried a 16-inch water main. It was the nearest steel water crossing to GZ. It was a bow-string truss, built of light, steel angle members, and was supported on concrete piers. The blast caused slight deformation of the truss members. The members adjacent to the west abutment were most severely affected by the blast, and evidence indicated that the deformation of the members was caused by direct blast forces rather than by forces reflected from the water (Photos 85 and 86).

PHOTO 85-XII. Bridge 30-A. North elevation of aqueduct for 16-inch main over the Ota-Gawa. Slightly damaged by blast.

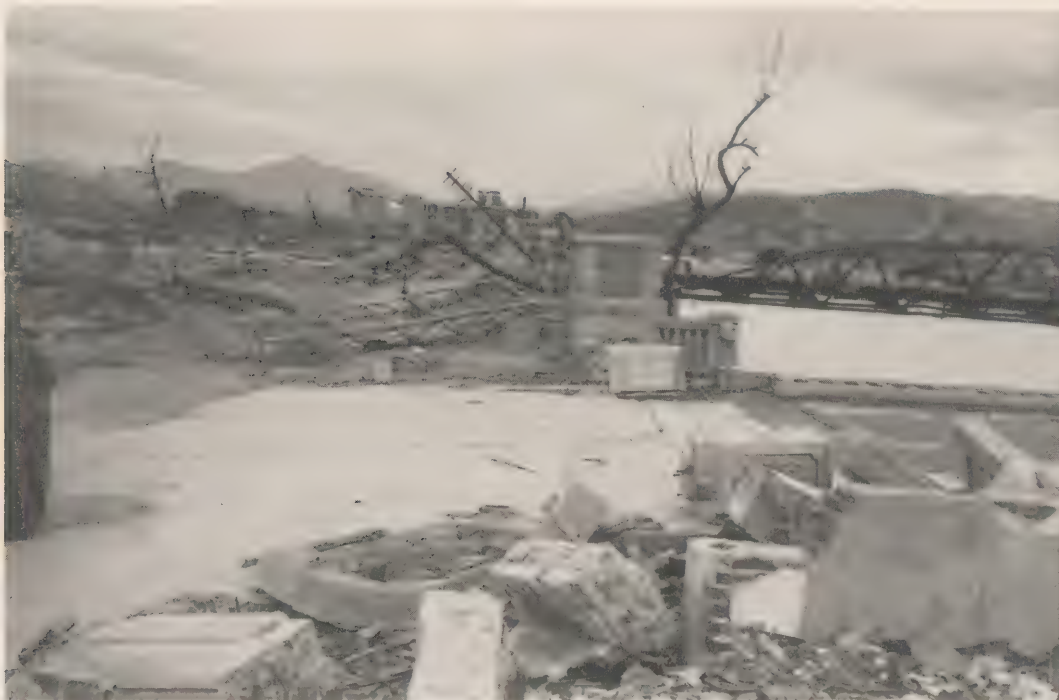
PHOTO 86-XII. Bridge 30-A. Looking northeast at corner of west abutment. Steel truss slightly damaged by blast. Note damaged covering of 16-inch water main (1,880 feet to GZ, 2,750 feet to AZ).

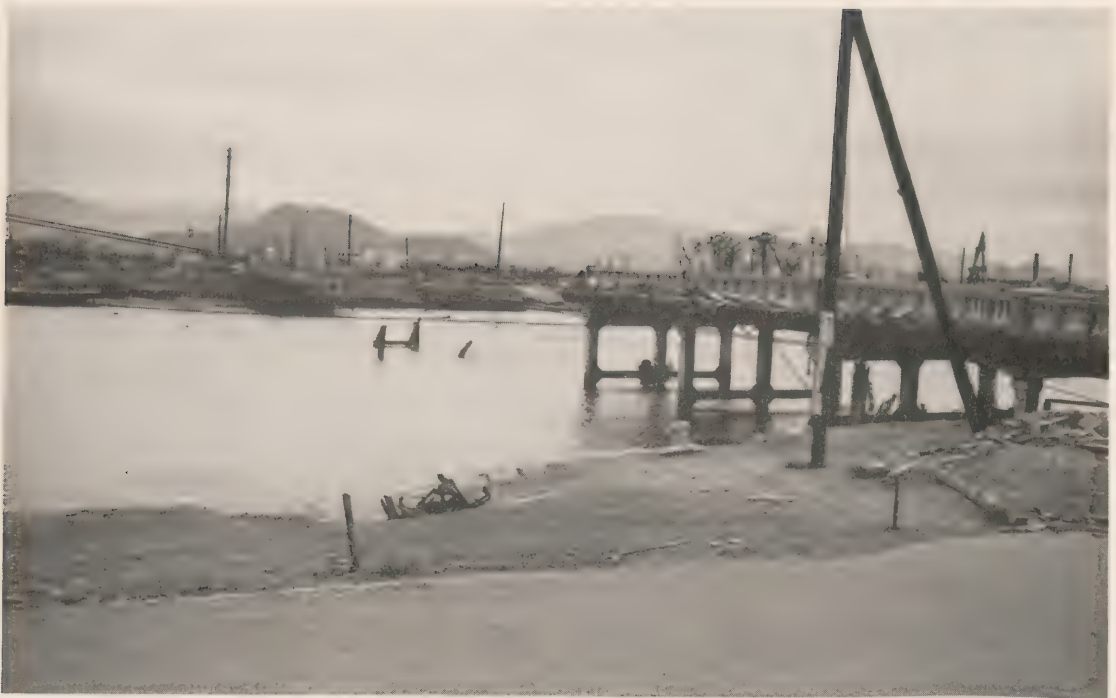
(11) *Bridge 31* (4,570 feet from GZ and 5,000 feet from AZ) suffered severe damage by flood (Photo 87).

PHOTO 87-XII. Bridge 31. Looking south at flood-damaged, highway bridge over the Ota-Gawa. Sixteen-inch water main carried by bents. Top portion of northwest corner post dislodged by blast (4,570 feet to GZ, 5,000 feet to AZ).

Top portion of NW corner post dislodged 3" to south.
Other posts not damaged.
Concrete railings not damaged.
Photo 87

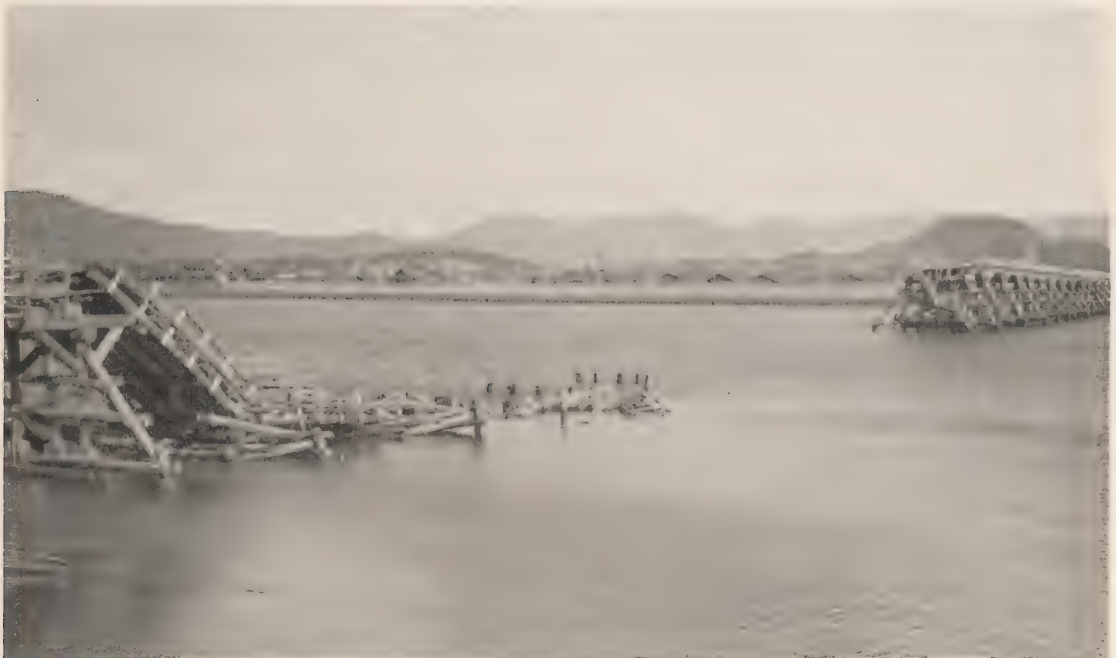
(10) *Bridge 32* (9,400 feet from GZ and 9,600 feet from AZ). The approximate middle portion of the bridge was severely damaged by flood (Photo 88).

PHOTO 88-XII. Bridge 32. Looking north at flood-damaged highway bridge over the Temma-Gawa (9,400 feet to GZ, 9,600 feet to AZ).

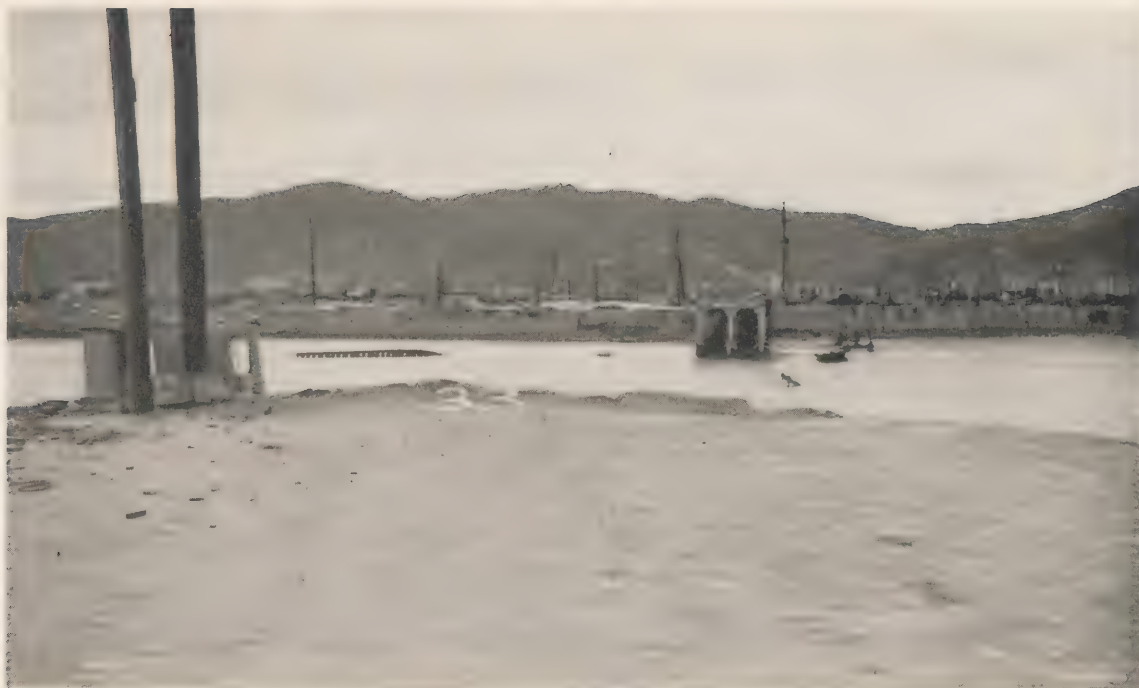
(12) *Bridge 33* (5,300 feet from GZ and 5,650 feet from AZ) suffered severe damage by flood (Photo 89).

PHOTO 89-XII. Bridge 33. Looking west at flood-damaged bridge over the Temma-Giawa. Sixteen-inch water main carried by bents (5,300 feet to GZ, 5,650 feet to AZ).

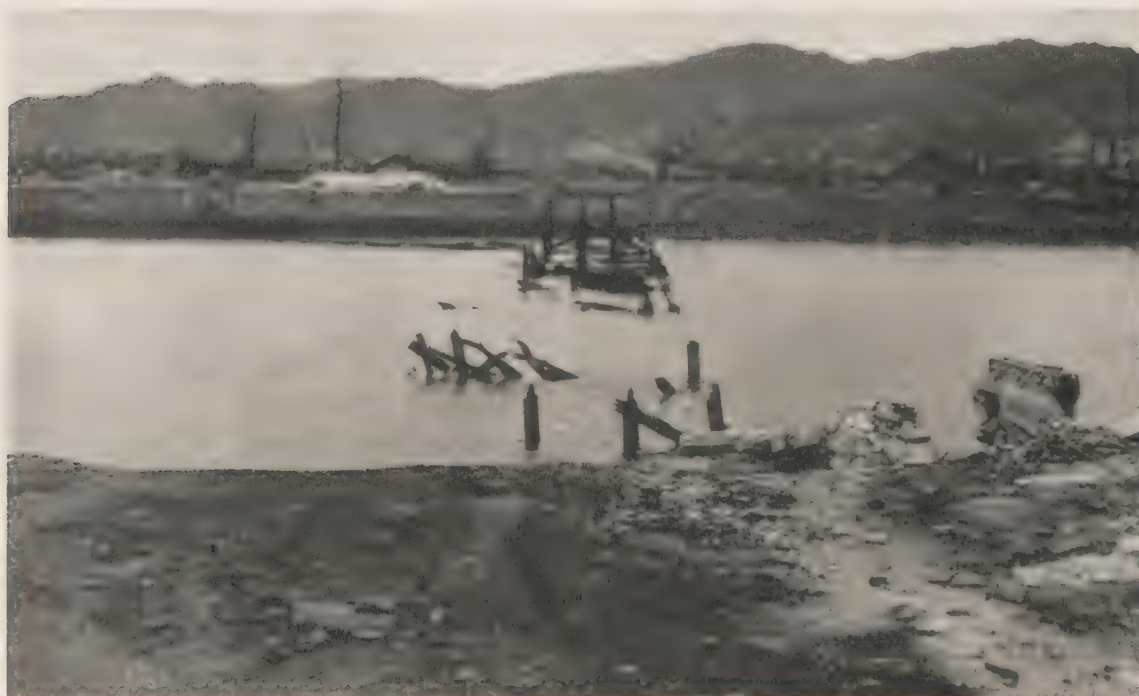
(11) *Bridge 34* (3,700 feet from GZ and 4,200 feet from AZ) was totally damaged by fire (Photo 90).

PHOTO 90-XII. Bridge 34. Looking west at timber bridge over the Temma-Gawa. Total damage by fire (3,700 feet to GZ, 4,200 feet to AZ).

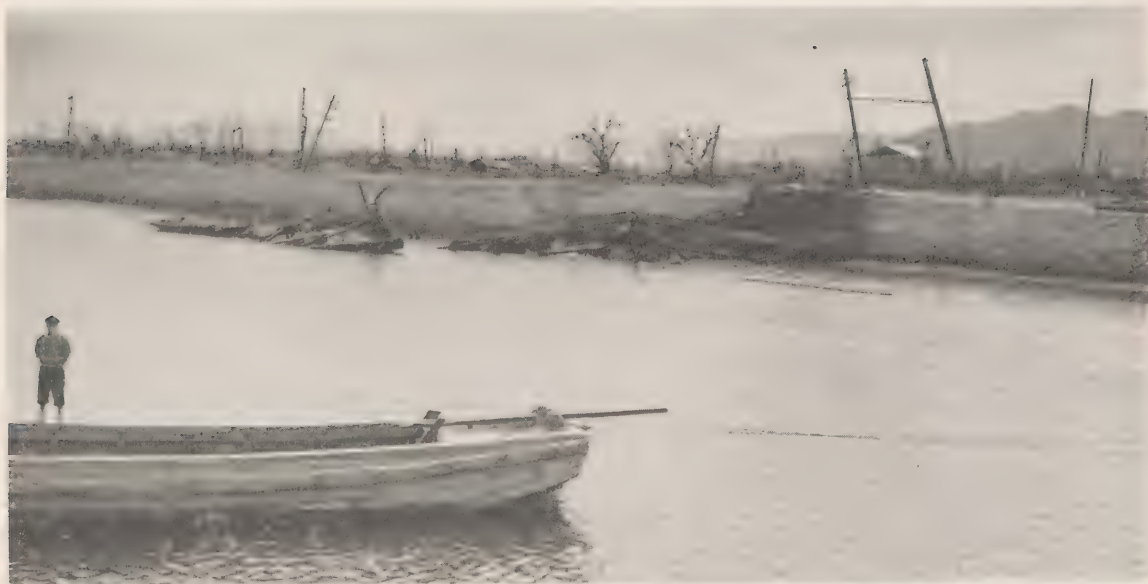
(17) *Bridge 35* (3,190 feet from GZ and 3,750 feet from AZ) was totally damaged by flood (Photos 91 and 92).

PHOTO 91-XII. Bridge 35. Looking north at east abutment of bridge over the Temma-Gawa. Totally damaged by flood.

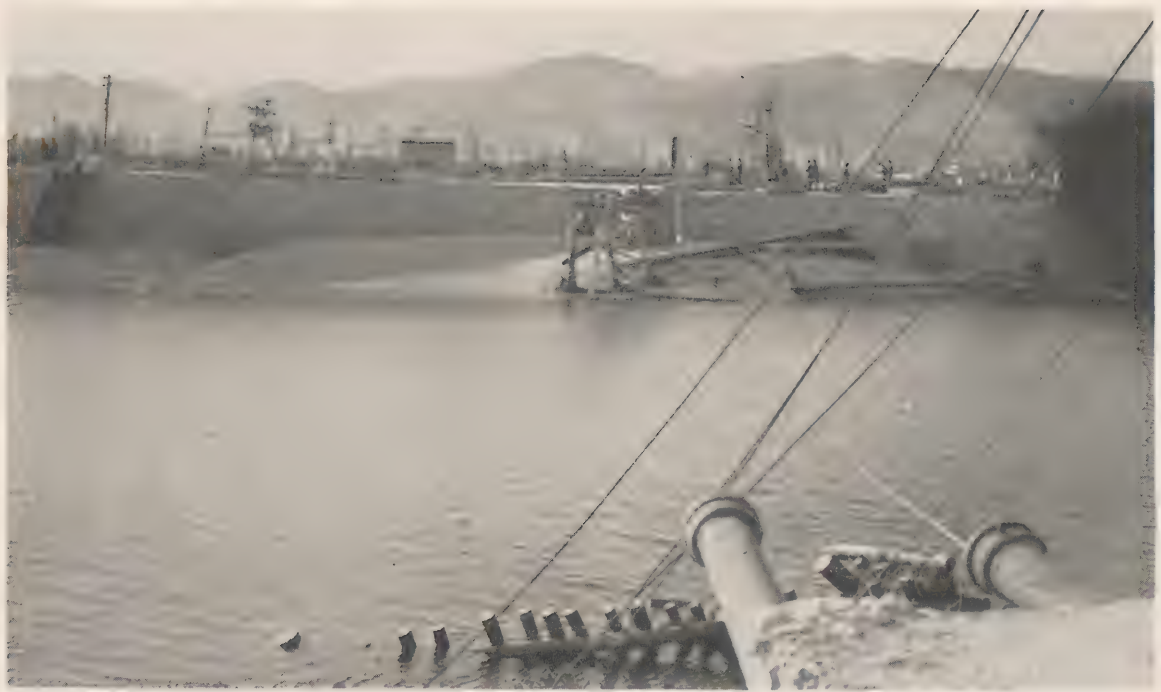
feet from AZ) was totally damaged by flood (Photo 93).

PHOTO 93-XII. Bridge 36. East and west abutment of bridge over the Temma-Gawa. Totally damaged by flood (3,200 feet to GZ, 3,760 feet to AZ).

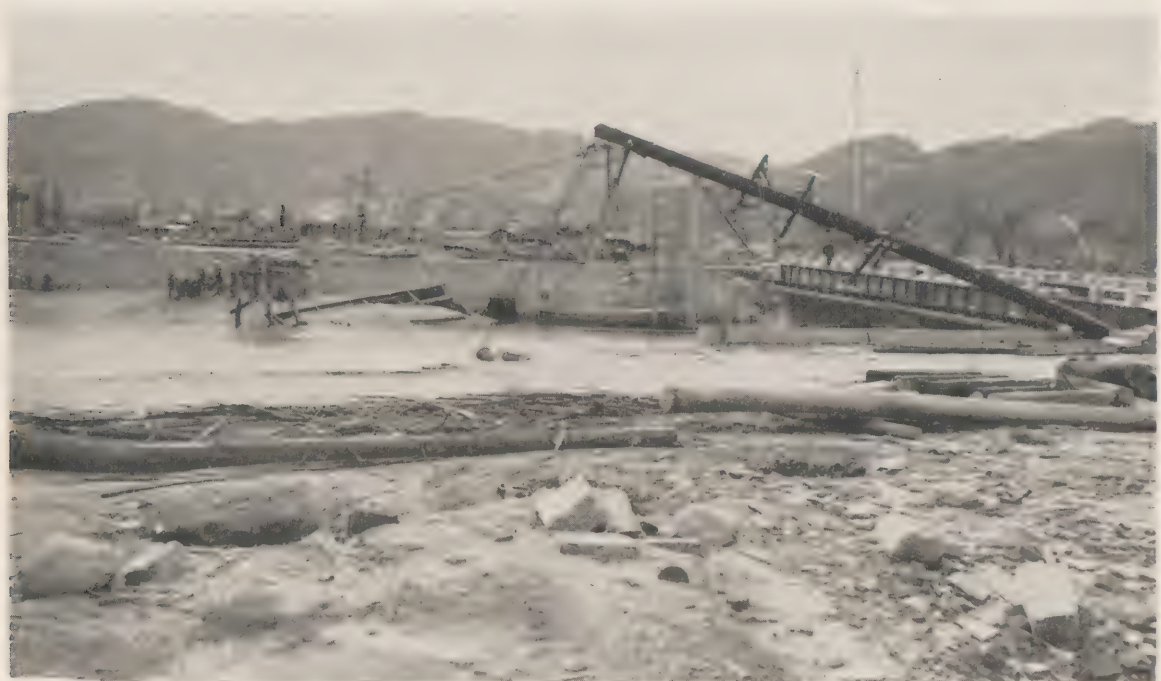
(18) *Bridge 37* (3,220 feet from GZ and 3,770 feet from AZ) suffered severe damage by flood which destroyed one pier and two spans adjacent to the west abutment (Photo 94).

PHOTO 94-XII. Bridge 37. Looking north at plate girder, wooden-deck, highway bridge over the Temma-Gawa. Westerly portion severely damaged by flood. Sixteen-inch water line carried by brackets along south side (3,220 feet to GZ, 3,770 feet to AZ).

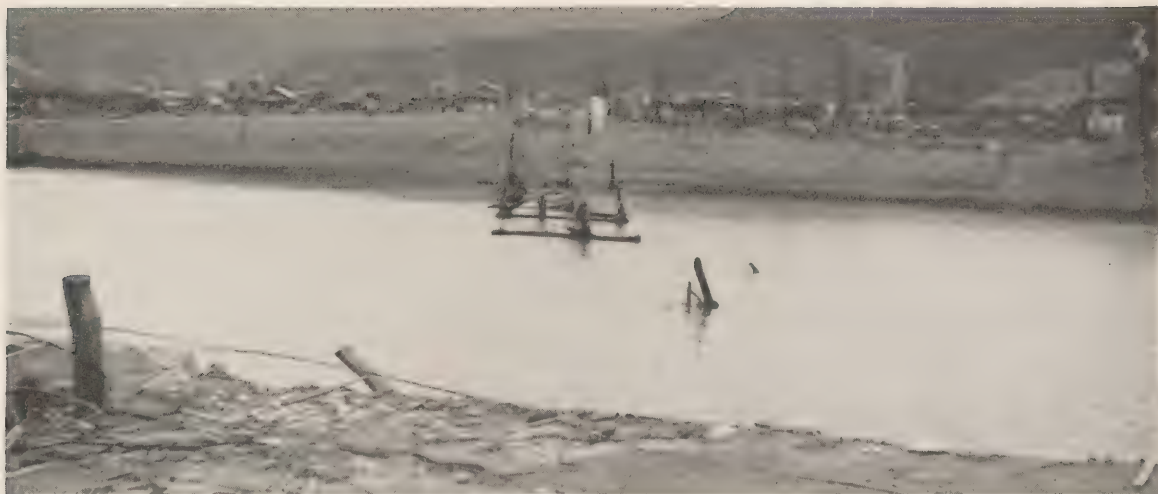
(13) *Bridge 38* (3,750 feet from GZ and 4,250 feet from AZ). Initially the westerly half of the bridge was severely damaged by fire spreading from adjoining areas and later was totally damaged by flood (Photo 95).

PHOTO 95-XII. Bridge 38. Looking west at remains of timber bridge over the Temma-Gawa. Severely damaged by fire (west half) and later totally damaged by flood (3,750 feet to GZ, 4,250 feet to AZ).

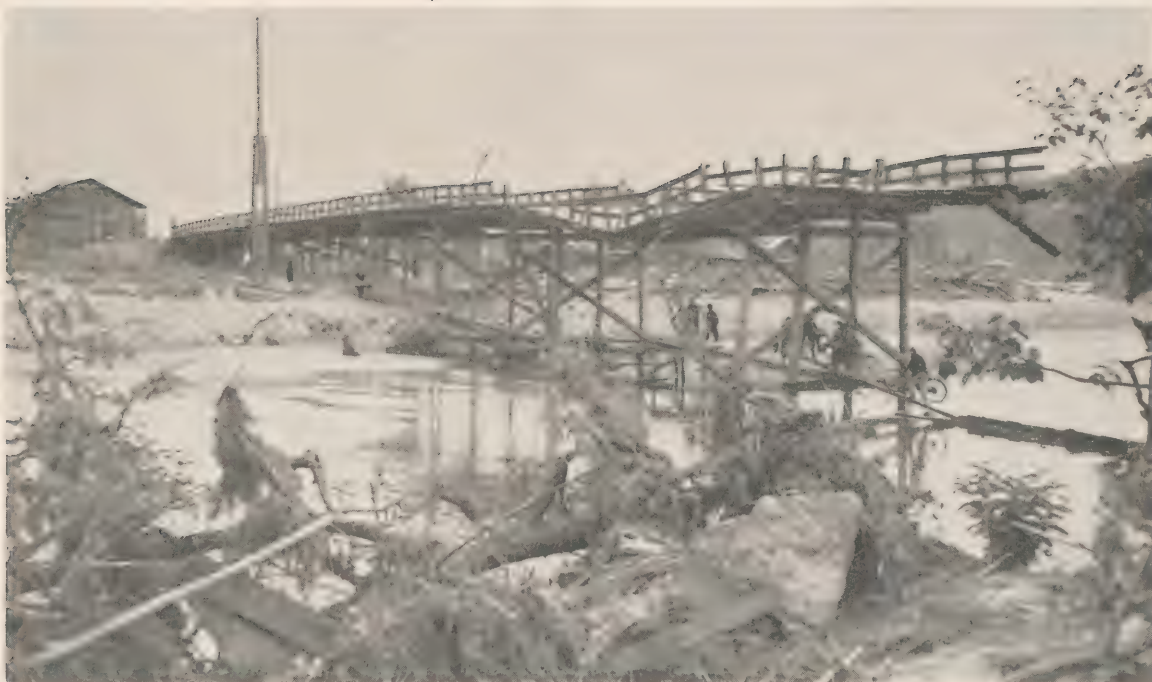
(15) *Bridge 40* (5,360 feet from GZ and 5,700 feet from AZ). The northerly portion of this bridge was severely damaged by fire (Photo 97).

PHOTO 97-XII. Bridge 40. Looking west at bridge over the Fukushima-Gawa. Northerly portion severely damaged by fire (5,360 feet to GZ, 5,700 feet to AZ).

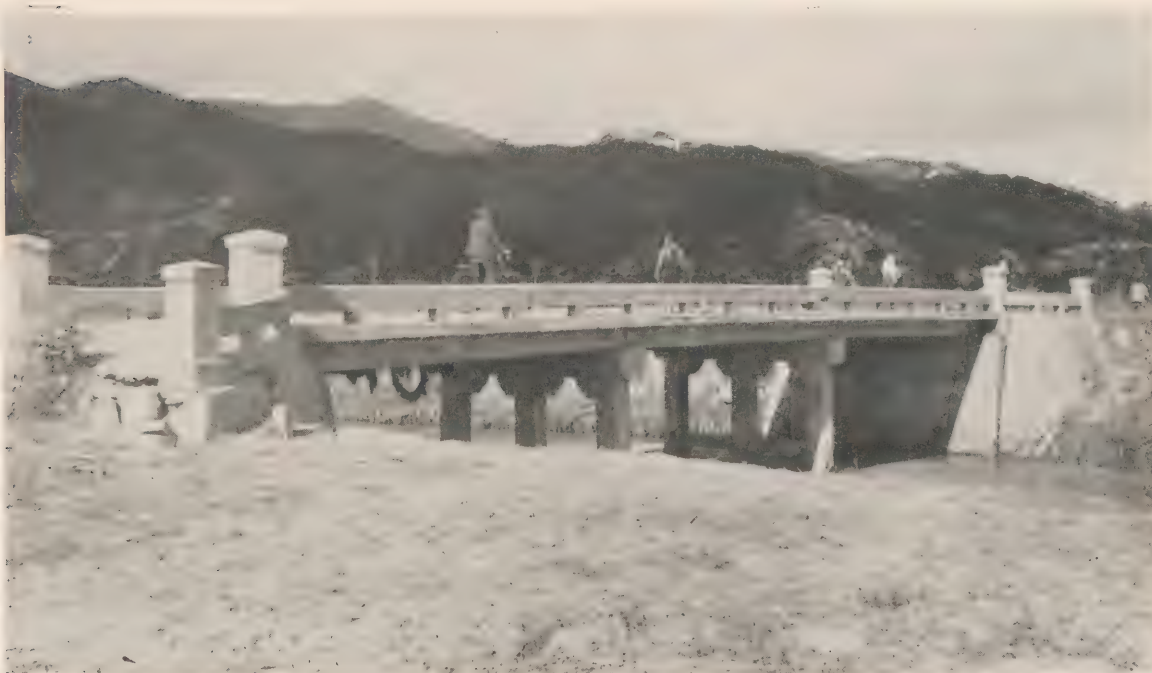
(13) *Bridge 41* (6,150 feet from GZ and 6,460 feet from AZ) suffered no damage (Photo 98).

PHOTO 98-XII. Bridge 41. Looking west at undamaged concrete bridge over canal connecting the Yamate-Gawa and the Fukushima-Gawa (6,150 feet to GZ, 6,460 feet to AZ).

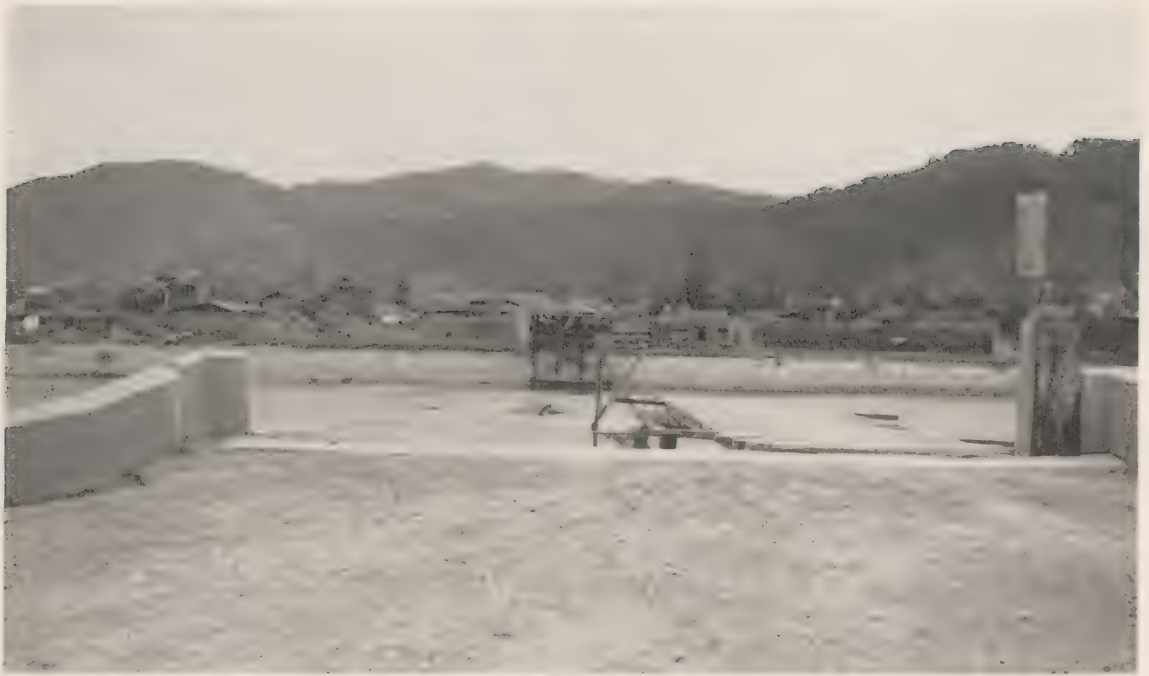
(16) *Bridge 42* (5,100 feet from GZ and 5,490 feet from AZ) was totally damaged by flood (Photo 99).

PHOTO 99-XII. Bridge 42. Looking west at remains of timber bridge over the Fukushima-Gawa. Totally damaged by flood (5,100 feet to GZ, 5,490 feet to AZ).

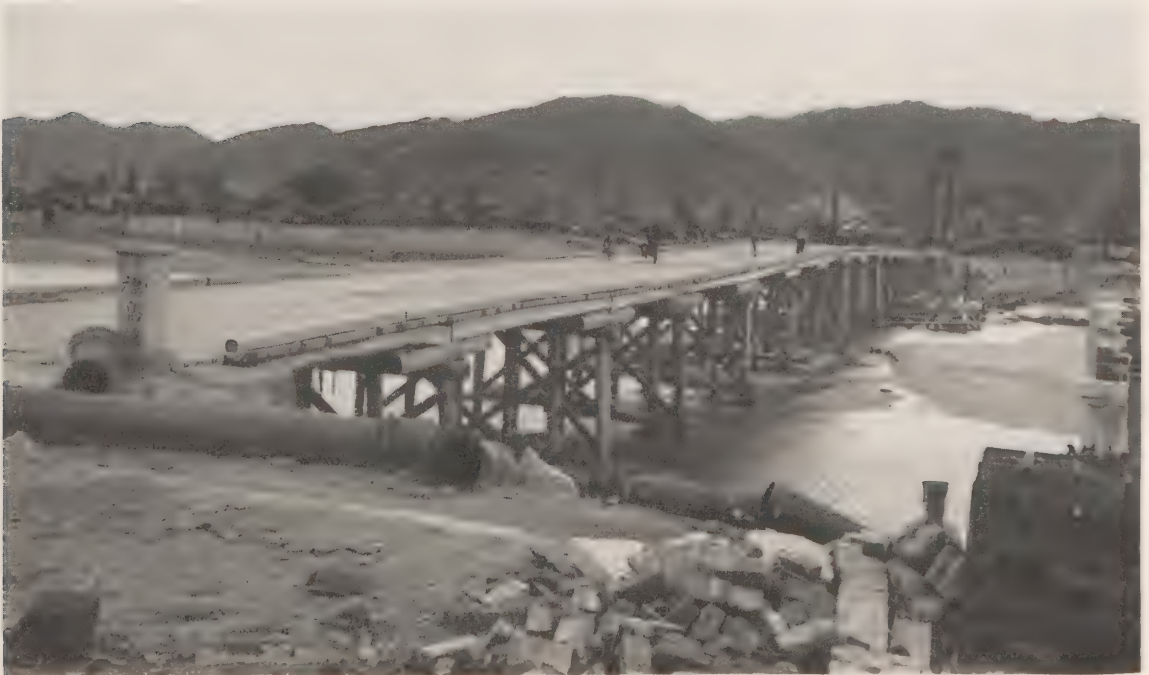
(17) *Bridge 43* (5,180 feet from GZ and 5,510 feet from AZ). The approximate midspan of this bridge was slightly damaged initially by blast and fire and later was totally damaged by flood (Photo 100). NOTE.—A new timber bridge was constructed.

PHOTO 100-XII. Bridge 43. North elevation of newly constructed timber bridge over the Fukushima-Gawa. Old bridge was totally damaged by blast and fire (5,180 feet to GZ, 5,510 feet to AZ).

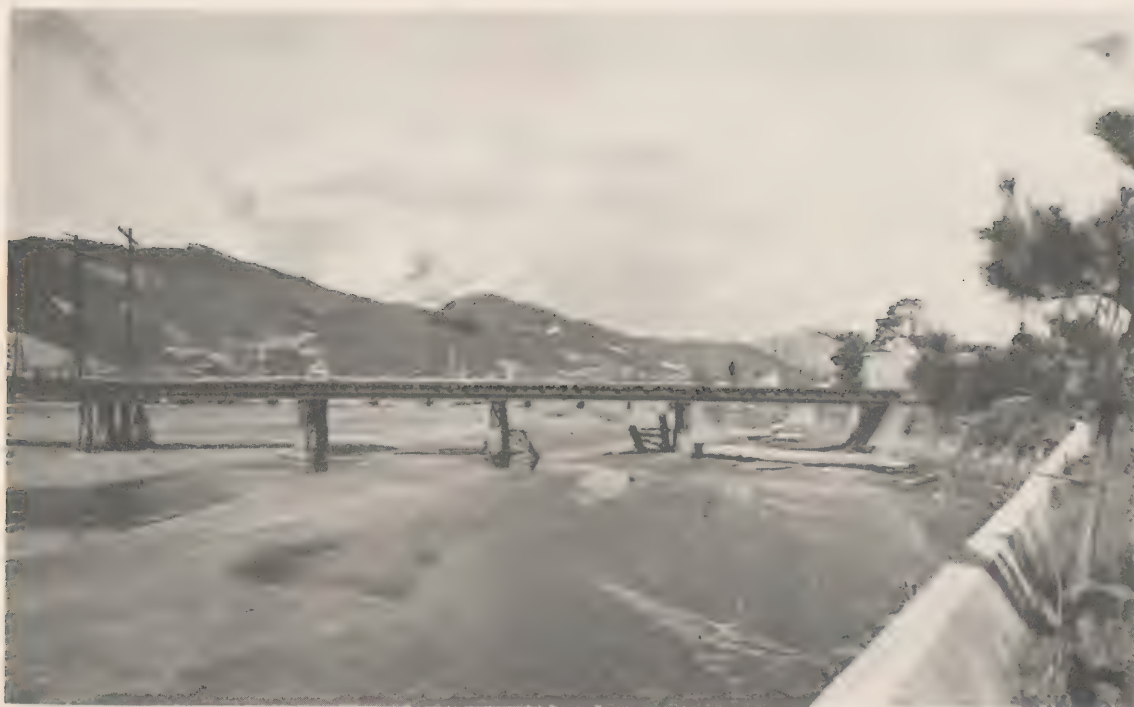
(19) *Bridge 44* (5,300 feet from GZ and 5,650 feet from AZ) suffered no damage (Photo 101).

PHOTO 101-XII. Bridge 44. Southeast part of undamaged, street railway bridge over the Fukushima-Gawa (5,300 feet to GZ, 5,650 feet to AZ).
